| Precision Auto Body & Collision<br>2000 W. Kellogg Rd. S.E.<br>Canton, OH (320) 555-0187 | | | | | Rocker/sill crushed - structural corrosion-protecti on layer breached |

Teardown inspection of the 2019 Volkswagen Jetta GLI (Progressive CLM-2026-00042) identified 16 supplement line item(s) reflecting damage beyond the original estimate. Structural components (radiator support / impact bar / frame members) are replacement-grade per manufacturer guidelines and require alignment and measuring-system setup after installation; straightening beyond OEM limits is not permitted. All replaced exterior panels are refinished to OEM 2-stage standards with adjacent-panel blending to ensure color match. Total supplement increase: \$5127.50 (43.6h @ \$65/hr labor + \$2293.50 parts).

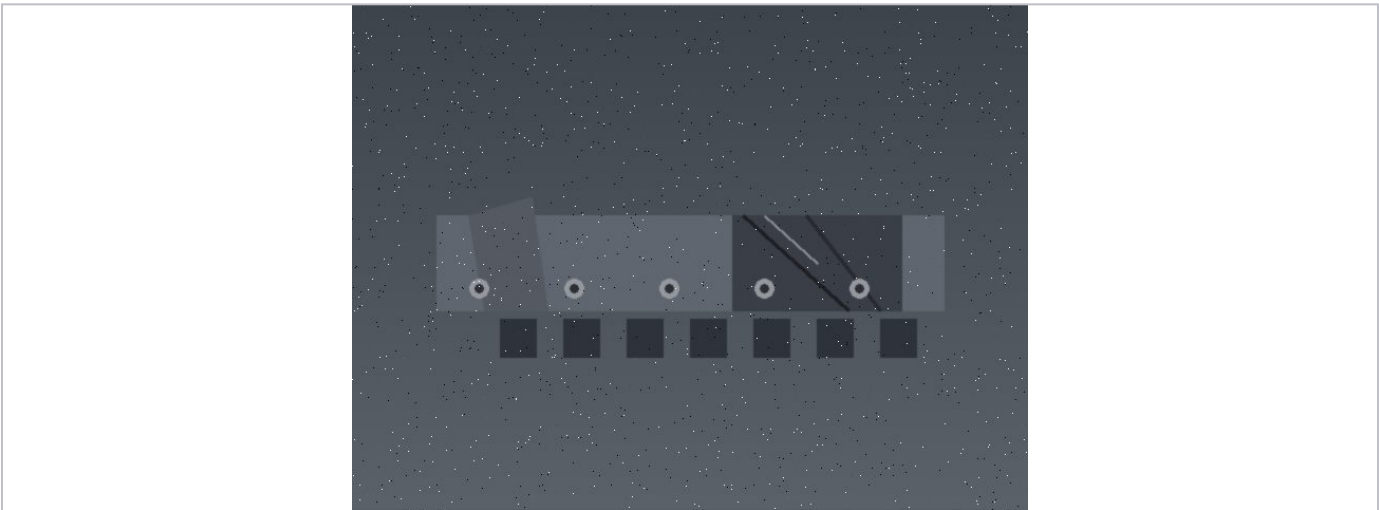
Photo 3 - impact-bar.jpg | Claim CLM-2026-00042

TECH NOTE (transcribed): "Impact bar pushed two inches into the radiator support. Needs full replacement, plus one and a half hours frame setup."

AI FINDINGS: - Front Bumper Cover: Damage identified during teardown inspection. | Suggested op: REMOVE\_REPLACE (confidence 90%)

- Front Bumper Cover: Damage identified during teardown inspection. | Suggested op: REMOVE\_REPLACE (confidence 90%)
- Concern: Front-end alignment / measuring system setup required after structural replacement

10. Front Bumper Impact Absorber (R&R): Per manufacturer guidelines, the bumper impact absorber is a crushable energy-absorption component; once deformed it cannot be straightened or reused and must be replaced to restore crash-energy performance.
